Manhole Inspection Summary

Manhole # S11C1_001MH

Record Plat: **11C1** Node: **001** Status: **Found**

Location Address: **S. Edgewood**

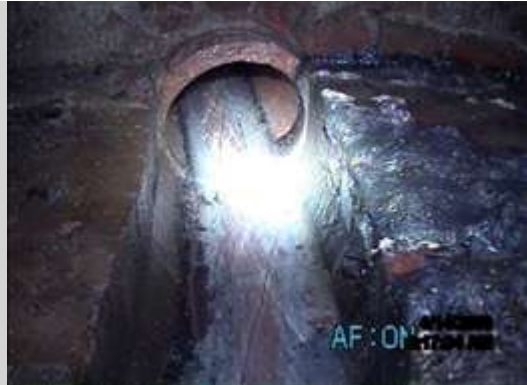
12 O'Clock Outflow

Pipe Height: **8.4** (in.) Rod and Bar (Angled)
Pipe Material: **Clay** ☐ Pipe Lined
Invert Depth: **13.46** (ft.) Flow Characteristics: **Fast**
Deposits: ☒ None ☐ Mud ☐ Sludge ☐ Debris ☐ Grease
Silt Depth: **0** (in.) Deposits Extent:
Infiltration: **None** Pipe Seal Cond: **Sound**

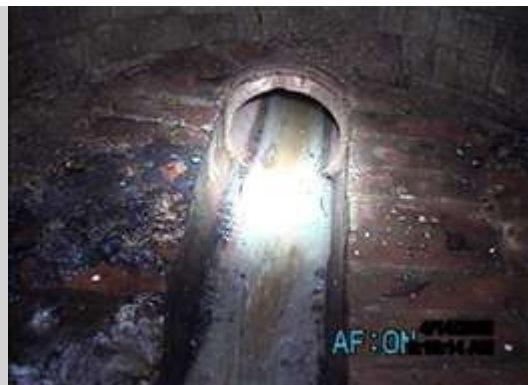
7 O'Clock Inflow

Pipe Height: **8.4** (in.) Rod and Bar (Angled)

Infiltration: **None** Pipe Seal Cond: **Sound**
